# GS2970/GS2971 Errata

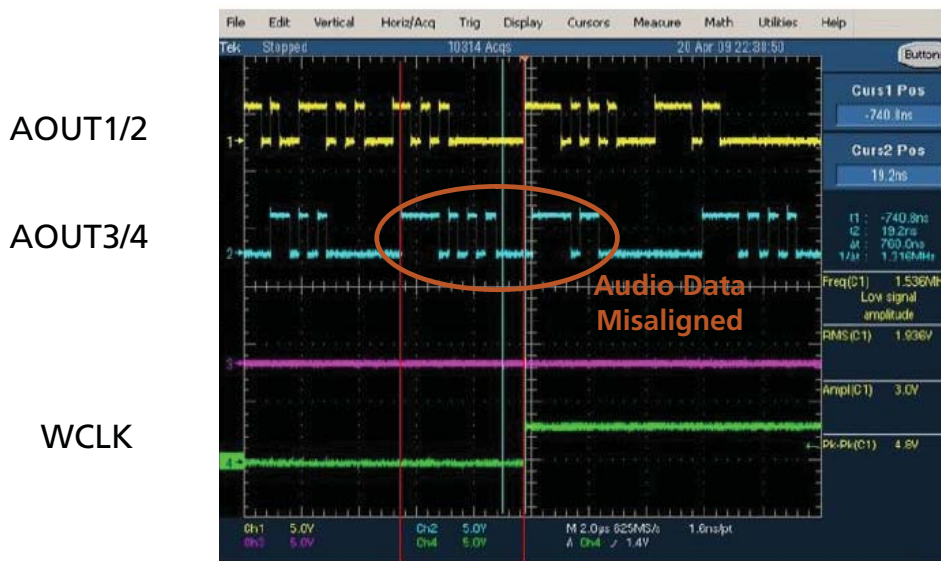
Figure 1-1: Audio Channel Misalignment

Audio outputs AOUT3/4, AOUT5/6 and AOUT7/8 may be misaligned, as shown in Figure 1-1:

The problem occurs randomly after the device has locked or re-locked to the video source. Sometimes all channels will be aligned to WCLK and sometimes not.

This problem occurs due to an internal audio word clock offset for audio outputs 3 through 8 caused by misdetection of the audio 5-frame sequence. The device only has one WCLK output taken from the source of AOUT1/2. The system is unable to detect the misalignment of audio outputs 3 through 8 since their respective word clocks are not provided external to the device.

Genum will provide FPGA IP code as a workaround for this bug.

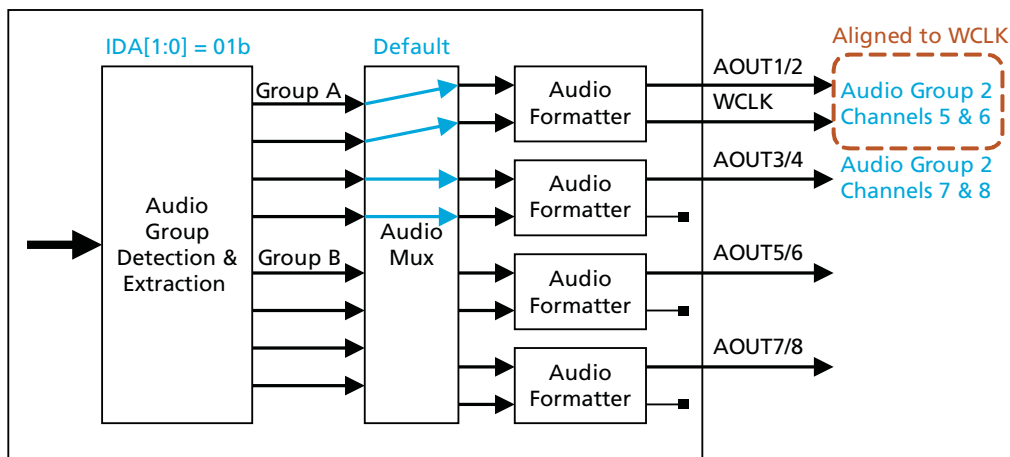
Figure 1-2: Audio Group 2 Selected as Primary Audio Group

Since AOUT1/2 is always aligned to the WCLK output, the first two channels of audio from the selected primary audio group will always be aligned to WCLK. By default, audio channels 1 and 2 from embedded audio Group 1 (primary audio group) will always be aligned to WCLK. If embedded audio Group 2 is set as the primary audio group, audio channels 5 and 6 will always be aligned to WCLK. See Figure 1-2 below. The primary audio group is selected using the IDA[1:0] bits in register 400h.

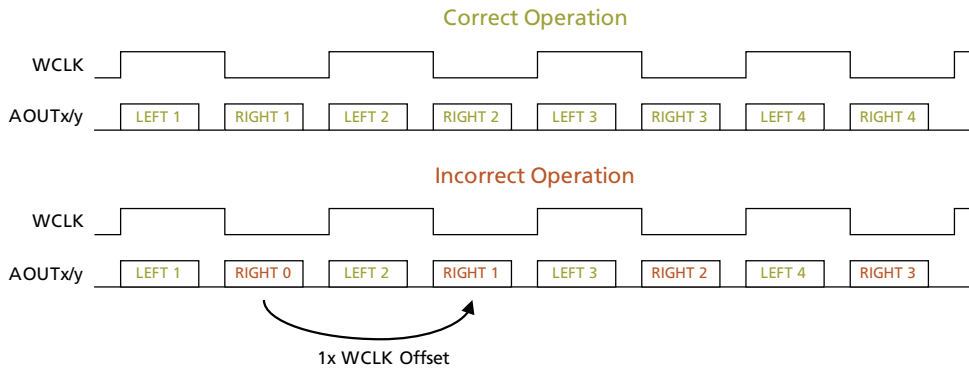
Figure 2-1: Audio Channel Offset

Within an audio channel pair, one of the channels (left or right for stereo) may be offset by one WCLK with respect to the samples original position. This is illustrated in Figure 2-1 below.

This offset can occur in any of the channel pair outputs, AOUT1/2, AOUT3/4, AOUT5/6 or AOUT7/8, and in any of the audio output modes, including AES. The offset can also occur with the first or second channel within an audio channel pair. The problem occurs randomly after the device has locked or re-locked to the video source.

Currently, no workaround is available for this issue.
