**LC03-3.3 Testing to
 Bellcore 1089 Intra-building**

Test Setup

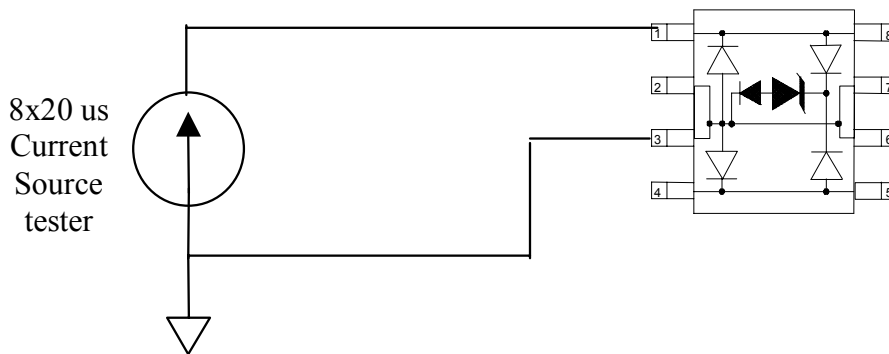
Figure 1 . Common Mode

derived current waveform has a duration of $2/10\mu\text{s}$. Since this is a test using a voltage source, the impedance of the unit under test can decrease the amount of current actually seen by the circuit. The test performed on Semtech's LC03-3.3 is a current source test. The purpose of using a current source tester is to insure that the current through the device is actually 100A. This provides for a worse case scenario and insures that the part will operate under worse case conditions. In addition, the test performed is an $8 \times 20\mu\text{s}$ surge. The $8/20\mu\text{s}$ pulse is longer in duration than the $2/10\mu\text{s}$. This means the test performed on the devices is actually a higher energy pulse than required by the Bellcore intra-building standard. Figure 1 shows the test setup for common mode. Figure 2 shows the test setup for differential mode.

An oscilloscope was used to display the voltage across the LC03-3.3 during a 100A 8/20 μ s double exponential pulse. Figure 1 is the configuration of the test performed. The current output by the tester is monitored on Ch1. The current ratio is 20A/100mV. The voltage between pin 1 and 2 of the LC03-3.3 is monitored on Ch2. Figure 3 shows the clamping

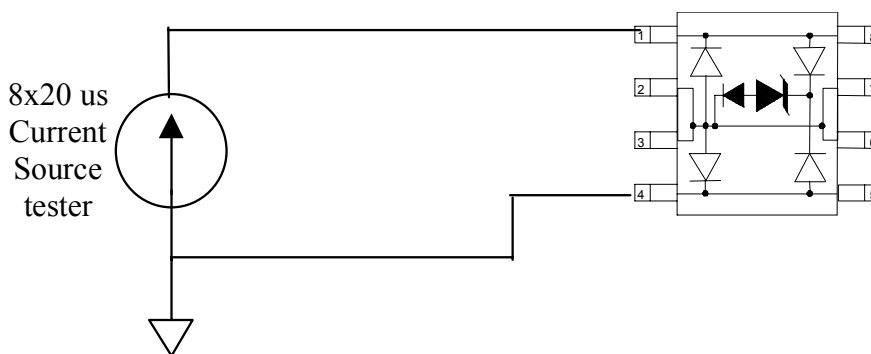
Figure 2 . Differential Mode

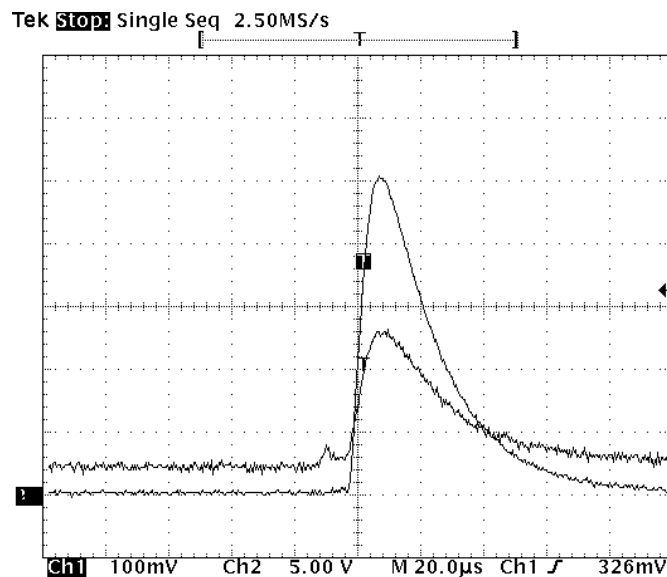
Figure 3. LC03-3.3 Clamping Voltage During 100A 8x20 μ s Surge

voltage of the LC03-3.3 from pin 1 to 2 during a 100A 8/20 μ s surge. The part is electrically tested after each surge to verify that the device is still operative. Figure 4 shows the typical clamping curve of the LC03-3.3 during an 8/20 μ s surge from 1 to 100A. Two curves are shown, line to line (differential mode) and line to ground (common mode).

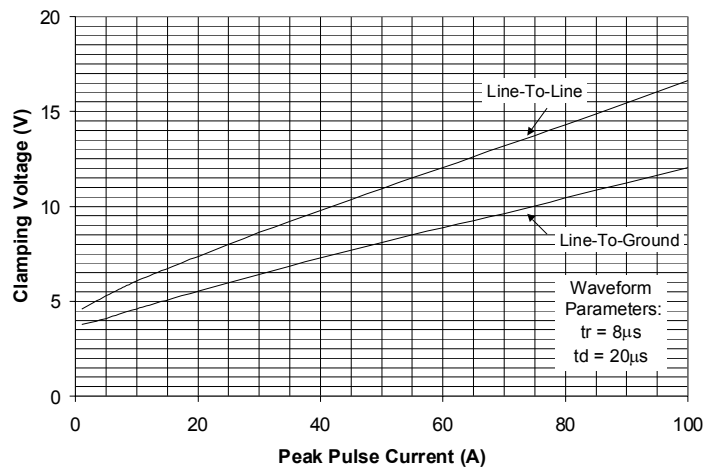
Figure 4. LC03-3.3 Typical Clamping Voltage vs. Peak Pulse Current
